AN OASIS FOR RAILROADERS IN THE MOJAVE
The History and Architecture of the Los Angeles and Salt Lake Railroad Depot,
Restaurant and Employees' Hotel at Kelso, California, on the Union Pacific System

Kelso Depot Historic Structure Report

National Preserve • California

January 1998

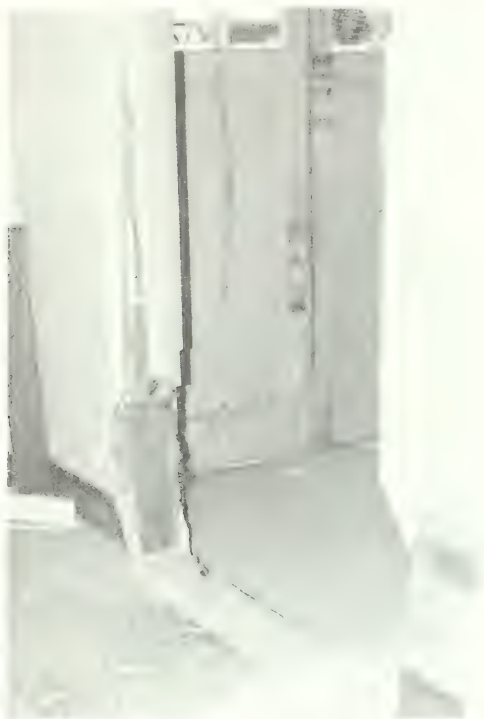
The original window in the west wall was removed when the west addition was constructed. The transom, window jambs and some hinges remain. The window sash, sill and wall below were removed to create a passage to the west addition but no door was installed. The broken plaster and cut lath (wood inside, metal outside) and the broken out section of concrete base were not patched, covered or trimmed out. The broken edges of the concrete base illustrate the red colorant additive used in the concrete mix.

Photo 71: West window of Conductor's Room removed in 1942 when west arcade addition was constructed. Photo by R. L. Carper, NPS, 1997.

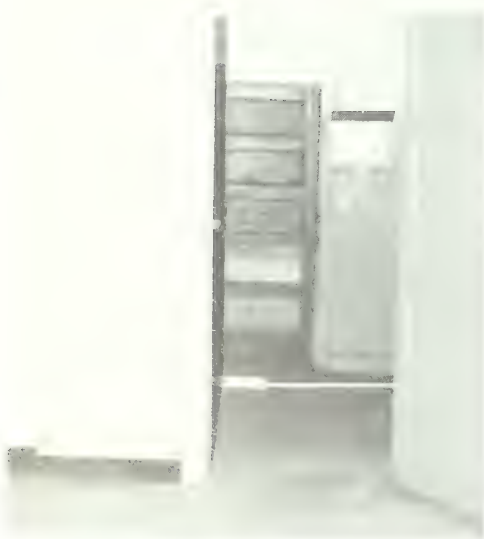
Photo 73: Baggage Room; in-fill and door in southwest wall at location of original double doors. Photo by R. L. Carper, NPS, 1997.

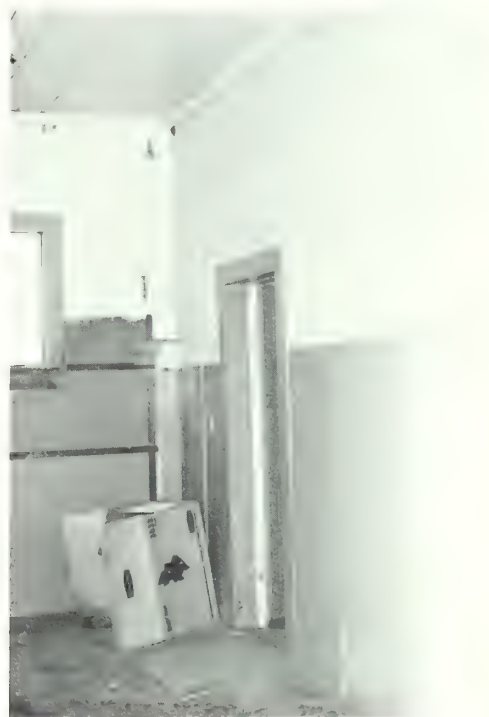
Photo 74: In-filled opening at original location of Baggage Room double doors as seen from west arcade, enclosed 1942. Photo by R. L. Carper, NPS, 1997.

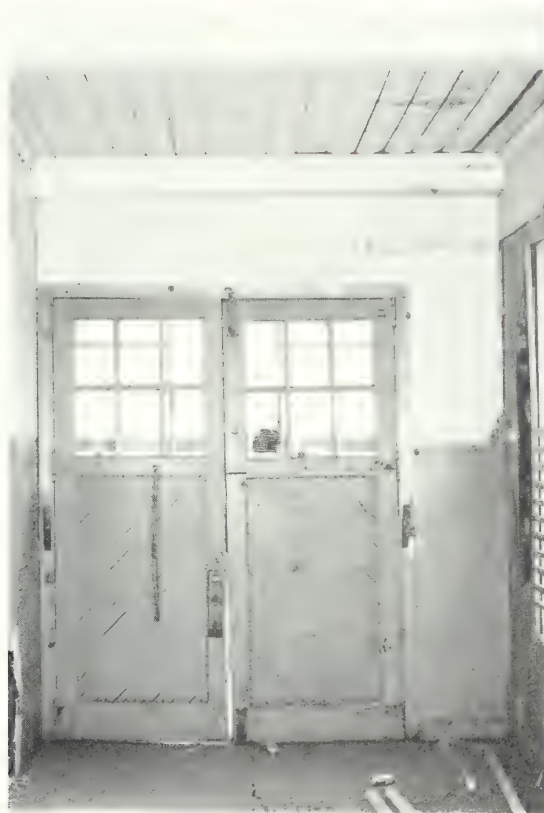
Photo 75: Original Baggage Room doors, relocated in 1942 to south end of west arcade addition. Photo by R. L. Carper, NPS, 1997.

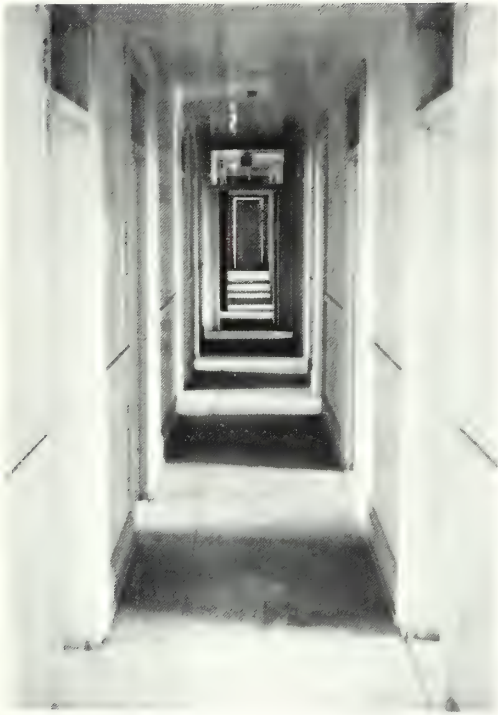
Photo 76: Second floor corridor. Photo by Gordon Chappell, NPS, November 13, 1996.

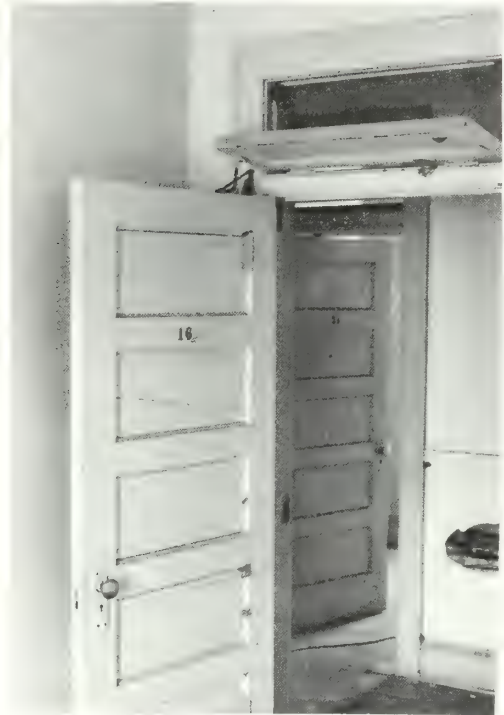
Photo 77: View from second floor room 16 on south side across hall to room 21 on north side showing typical doorways. Photo by Gordon Chappell, NPS, November 13, 1996.

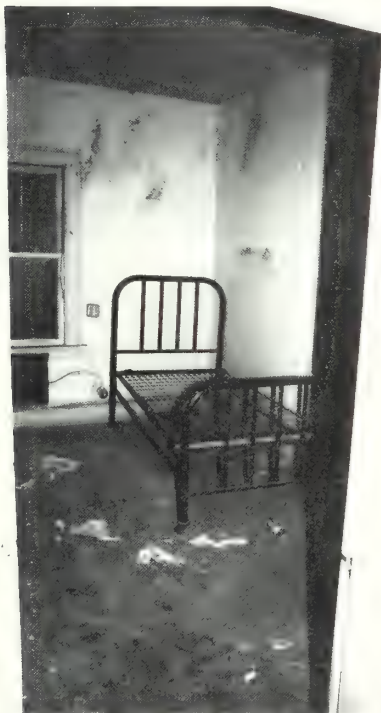
Photo 78: The second floor train crew lodging rooms were furnished with a metal bed frame and a clothes locker. Photo by John W. Snyder.

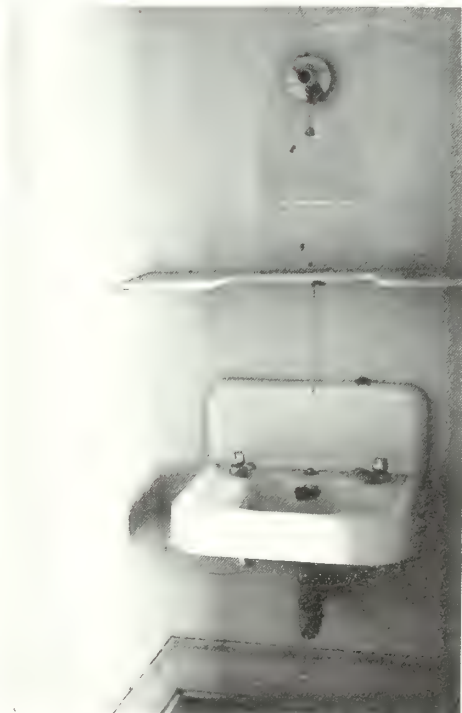
Some plumbing fixtures are original, some are later replacements. Most fixtures are in poor condition but some of the lavatories in the individual rooms may be possible to restore to usable condition. At a minimum, selected fixtures should be kept in the building artifact collection. Historic steam heating radiators were all replaced with electric heaters, probably in 1960 or 1961, which are now in poor condition.

Photo 79: The second floor lodging rooms on the north side for depot employees had a washbasin and built-in clothes closets. Photo by Gordon Chappell, NPS, November 13, 1996.

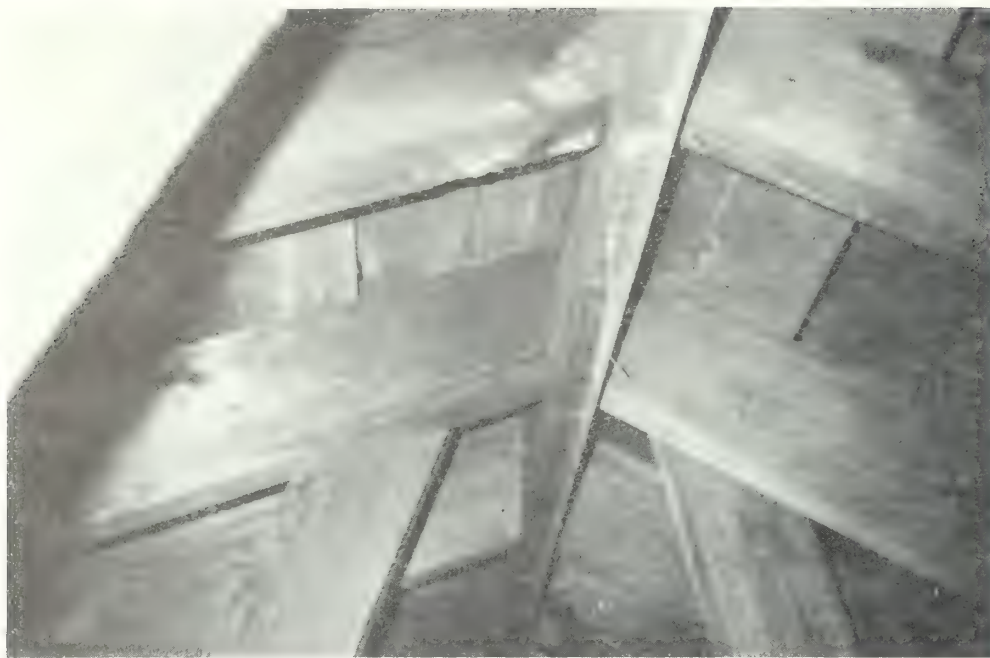
Photo 80: Detail of hipped roof framing at main ridge.

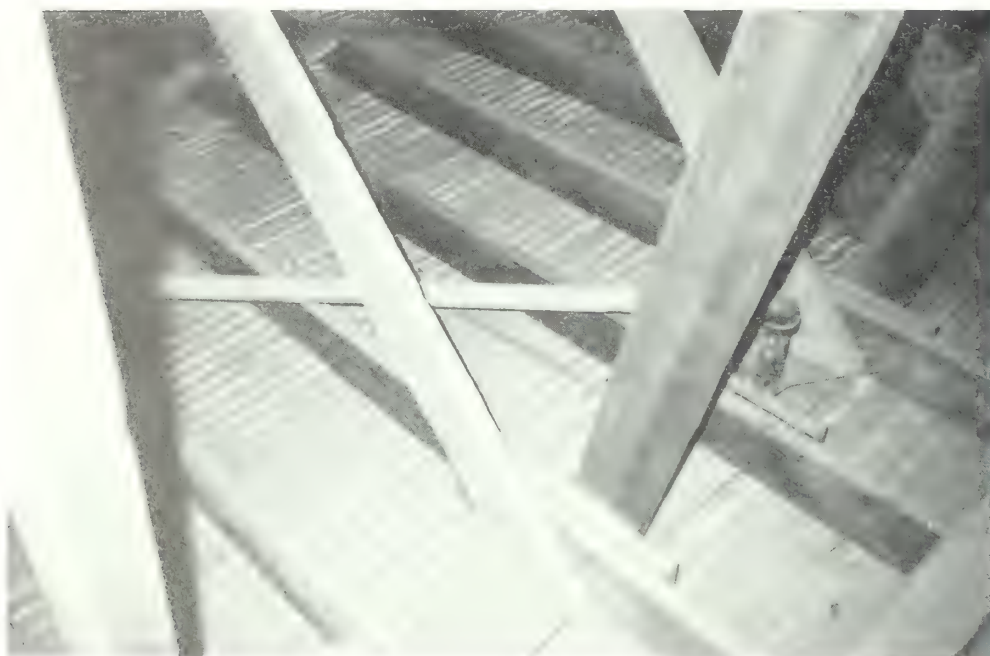
Overall, almost all of the roof framing is in excellent condition. Small areas of water damage in the hipped roof framing were observed along the south and west exterior walls, where the parapets intersect the roof valleys.

Photo 81: Hipped roof bracing connection at second floor ceiling joists.

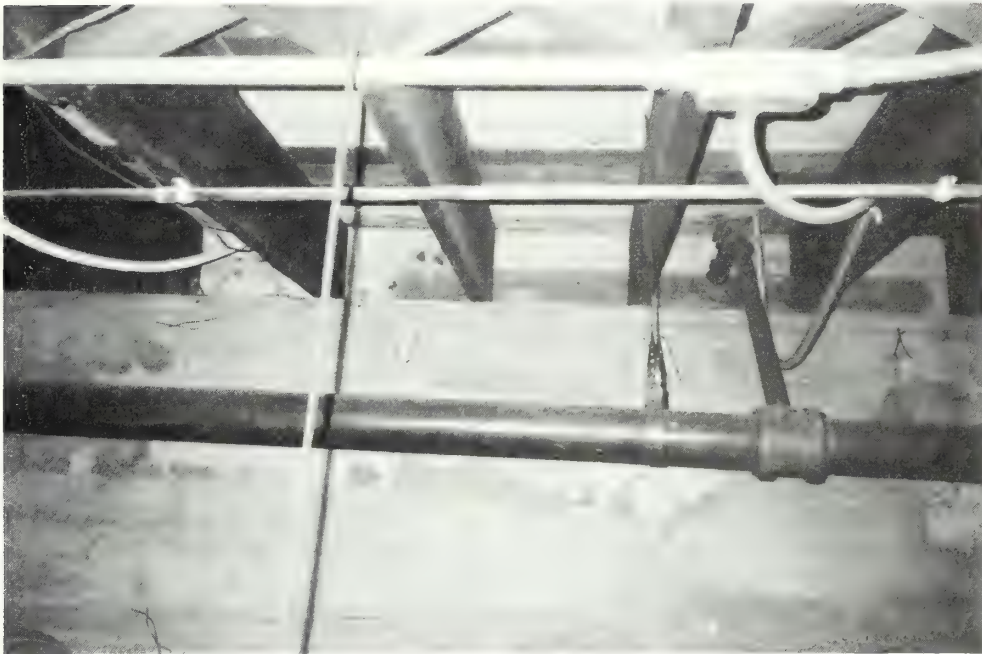
Photo 82: First floor framing at south exterior wall as seen in crawl space along south side of building.

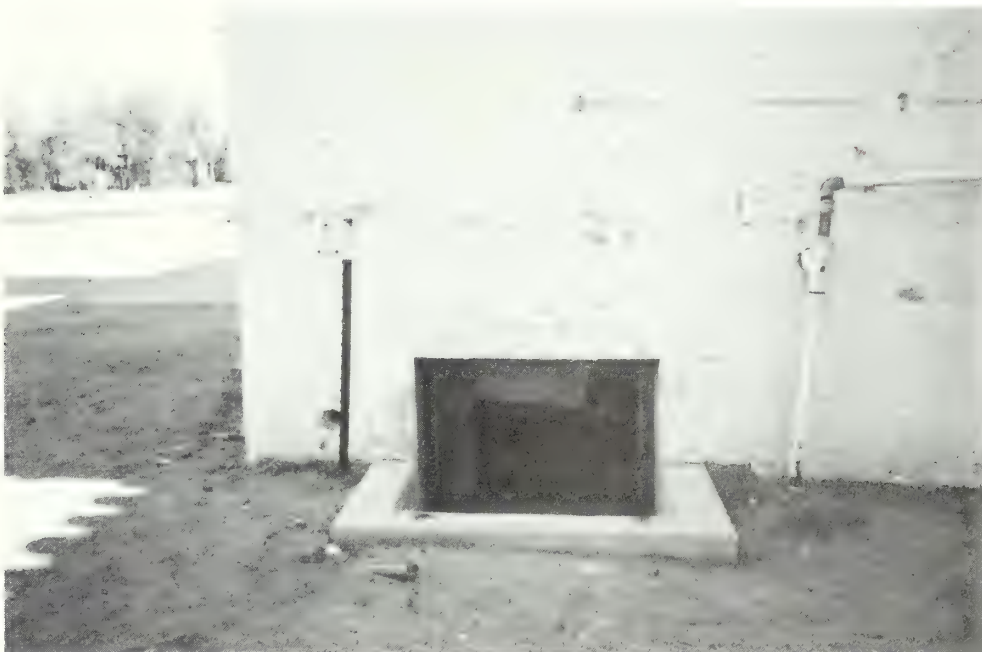
Photo 83: Concrete failure above basement Storeroom window at northwest corner of Kitchen wing caused by moisture from freezers in northwest corner of Kitchen.

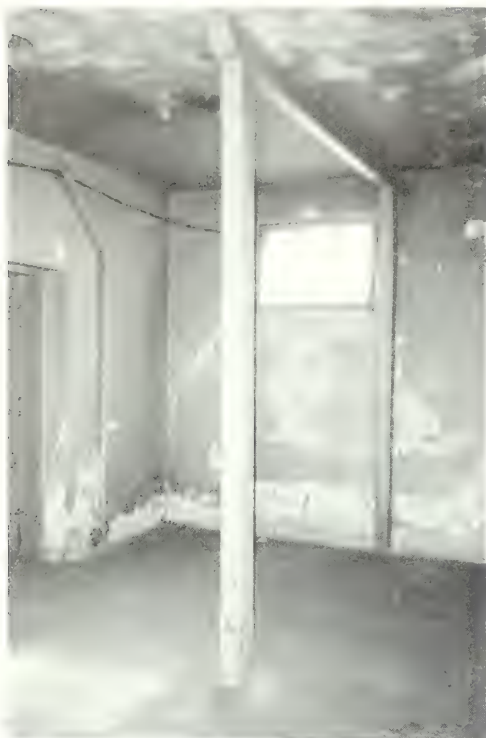
Photo 84: Wood columns and beam added in basement Supply Room; date unknown.

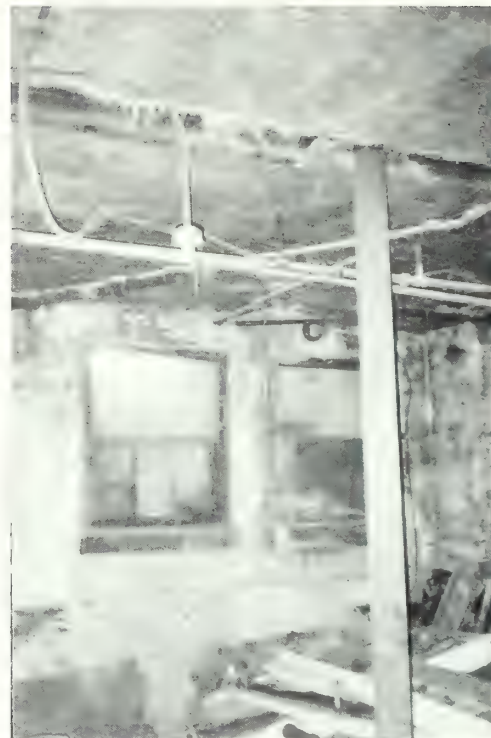
Photo 85: Southeast corner of Boiler Room. Column at center of room (right side in photo) and beam are a later addition and made up of railroad track rail.

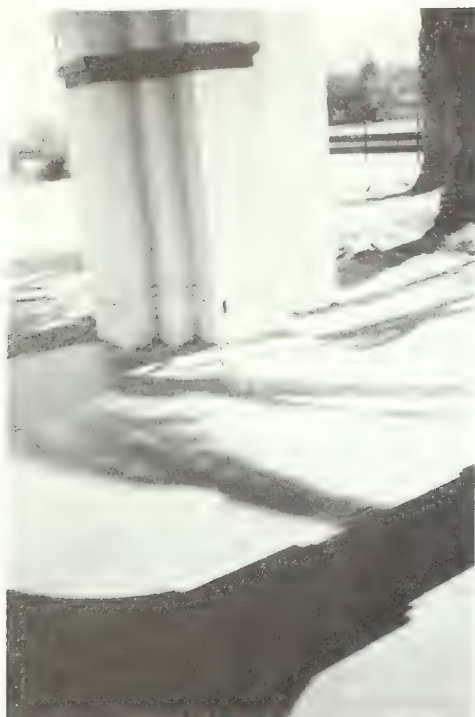
Photo 86: Colored and scored concrete paving at southeast corner of arcade. Water from clogged storm drains has caused cracking and heaving.

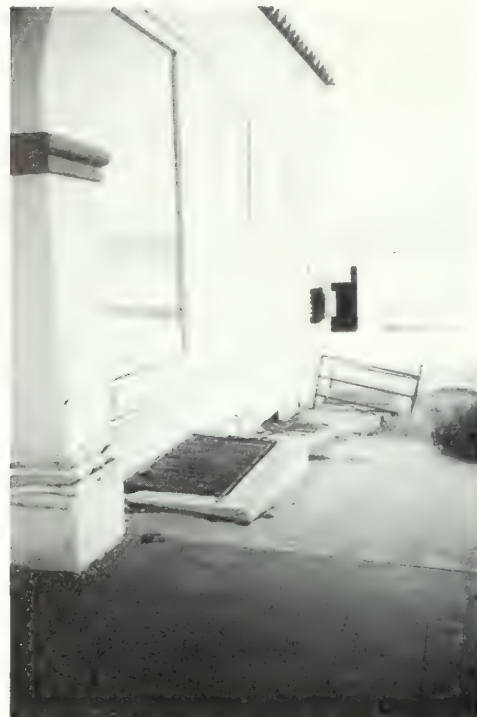
Photo 87: Deteriorated sidewalk along northeast wall of Boiler Room and Kitchen.

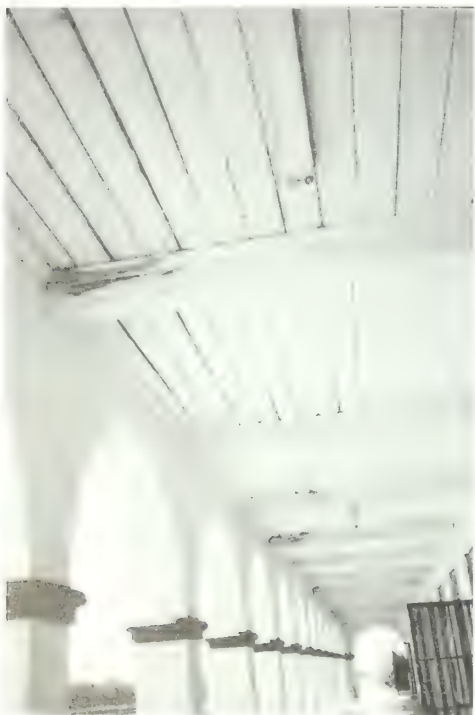
Photo 88: Deterioration of wood in arcade ceiling along south side of building.

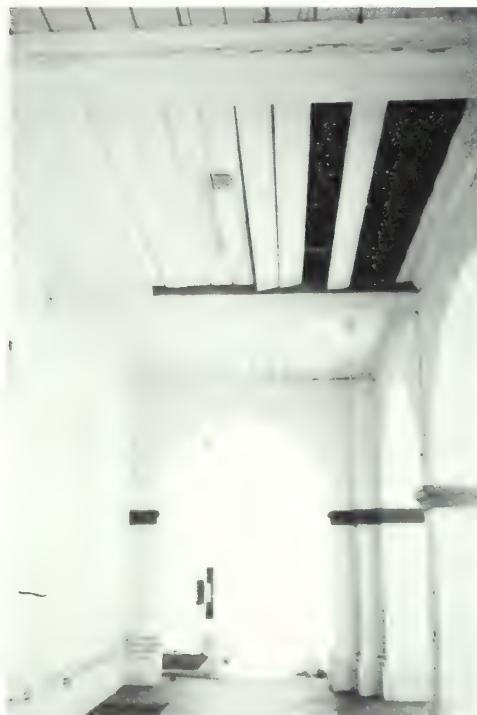
Photo 89: Missing boards in ceiling of arcade at northeast end of building.

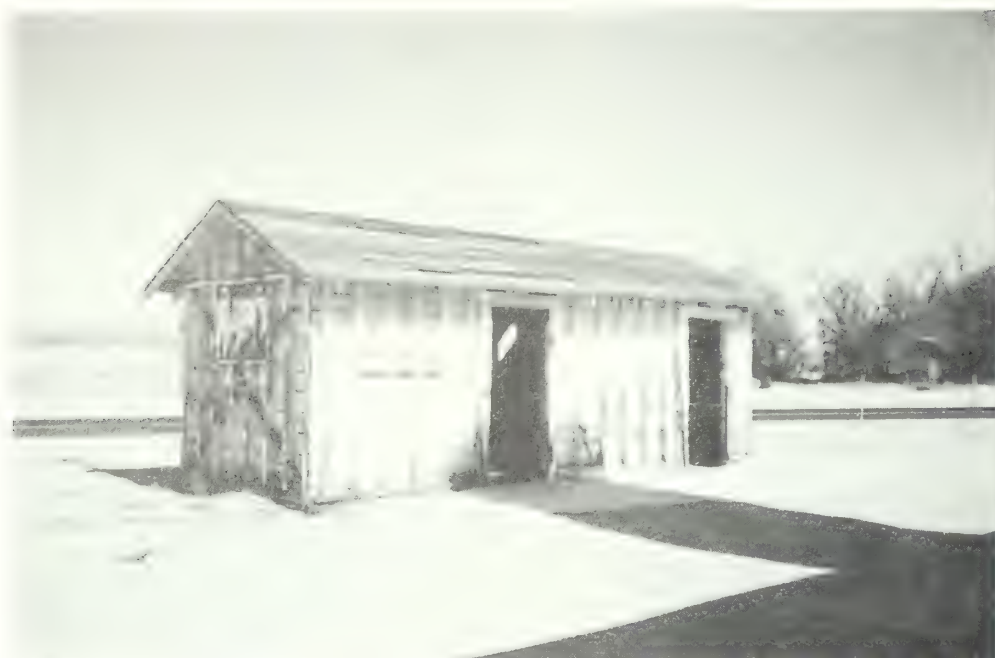
Photo 90: Coal and supply shed behind Depot. East half (at right) was an addition to the original.

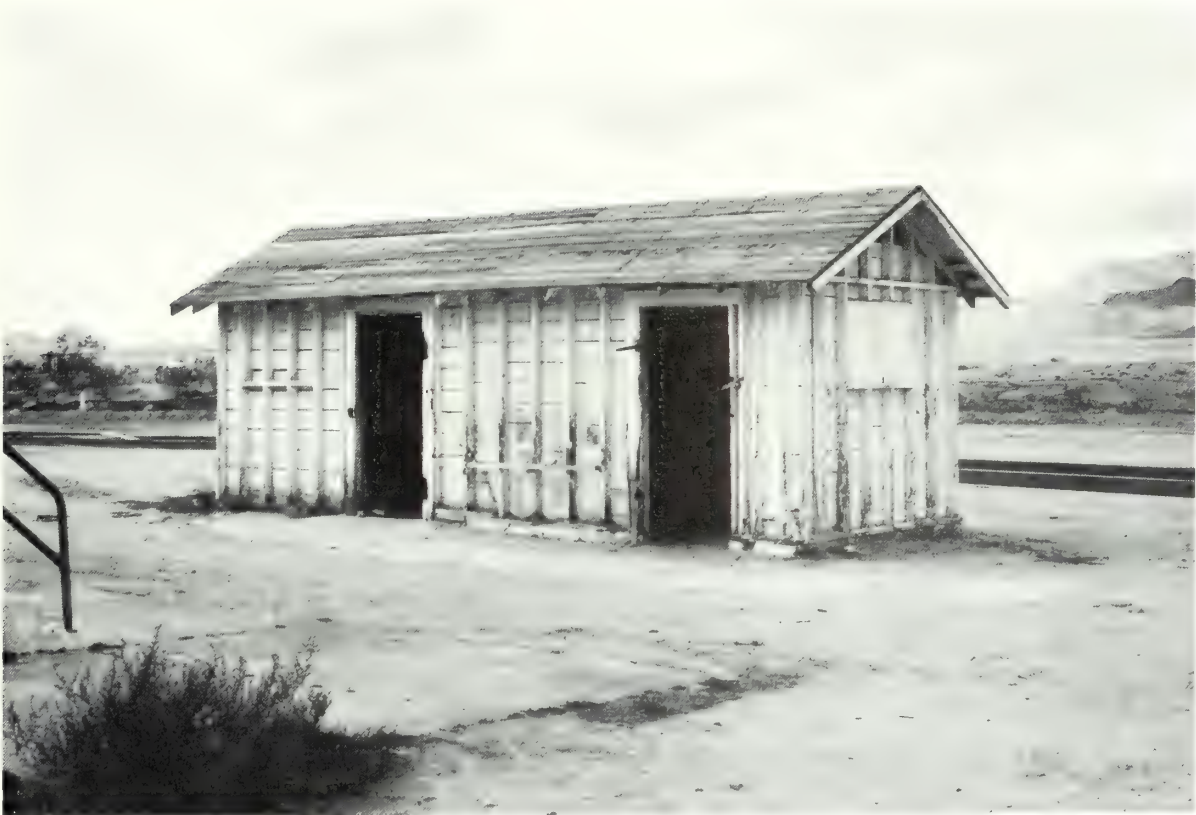
Photo 92: Wall framing of the coal and supply shed was left exposed. Photo by Gordon Chappell, NPS, February 8, 1995.

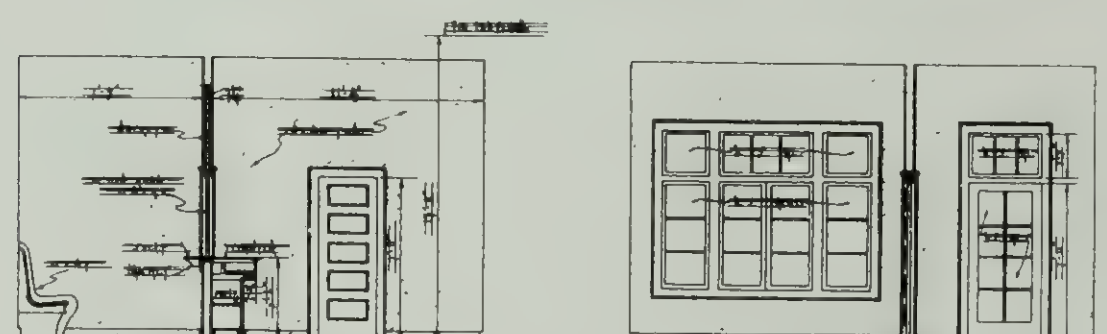
ELEVATION LOOKING NORTH
LUNCH ROOM

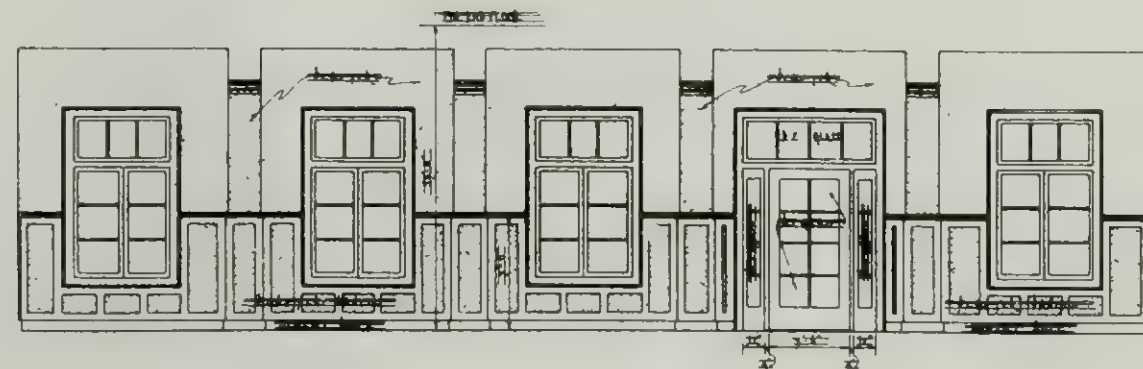
NORTH SIDE TRACK SIDE
ELEVATION OF CONDUCTOR ROOM & TICKET OFFICE

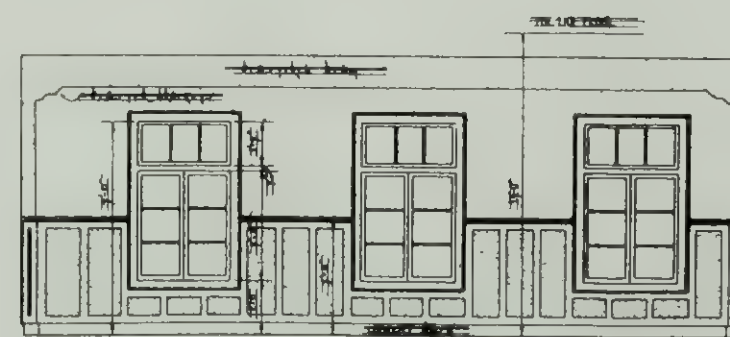
ELEVATION LOOKING SOUTH
LUNCH ROOM

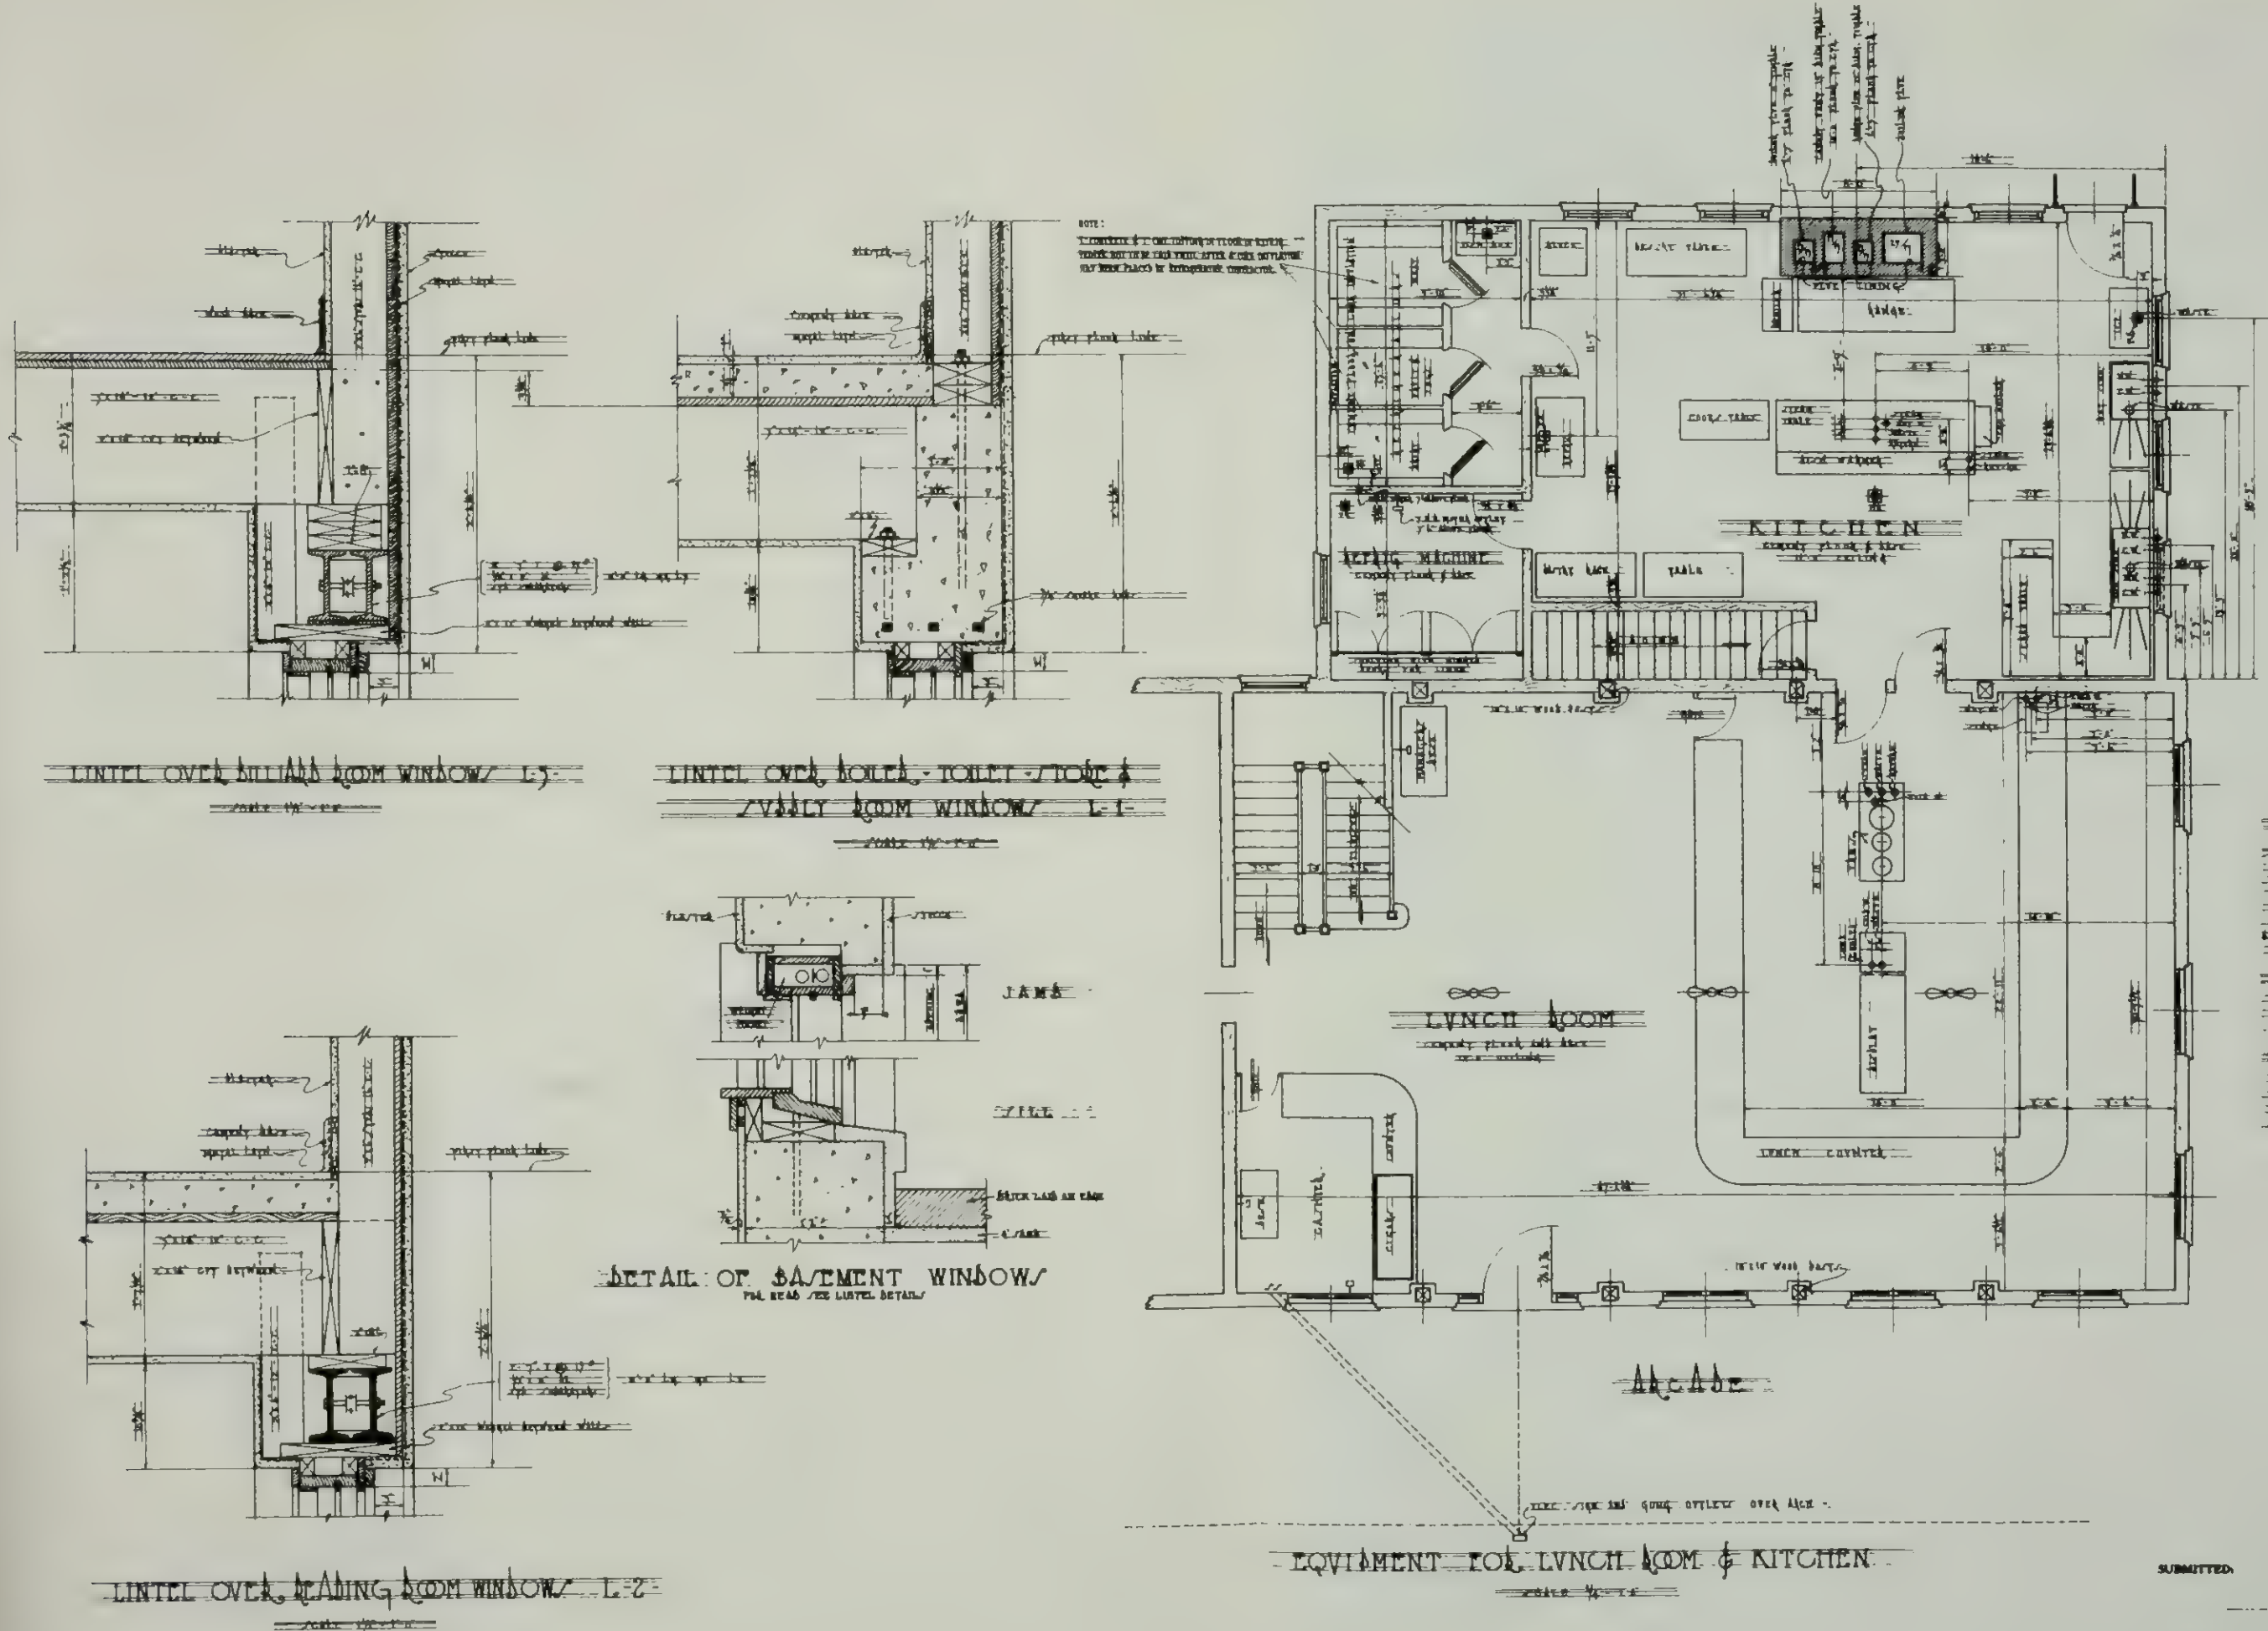
Drawing 7: Exterior Details, As Constructed, No. 170/25,900, Sheet 7 of 14, December 12, 1924, Union Pacific System.

1. LINTEL OVER MILLARD ROOM WINDOW L-3

2. LINTEL OVER BOUTA TOILET TOILET & VALLY ROOM WINDOW L-1

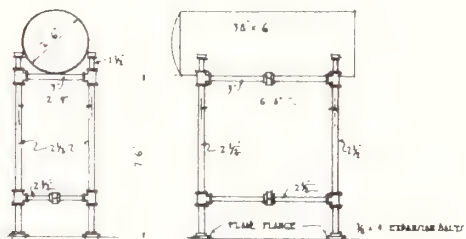
ELEVATION OF STORAGE TANK STAND
NO SCALE

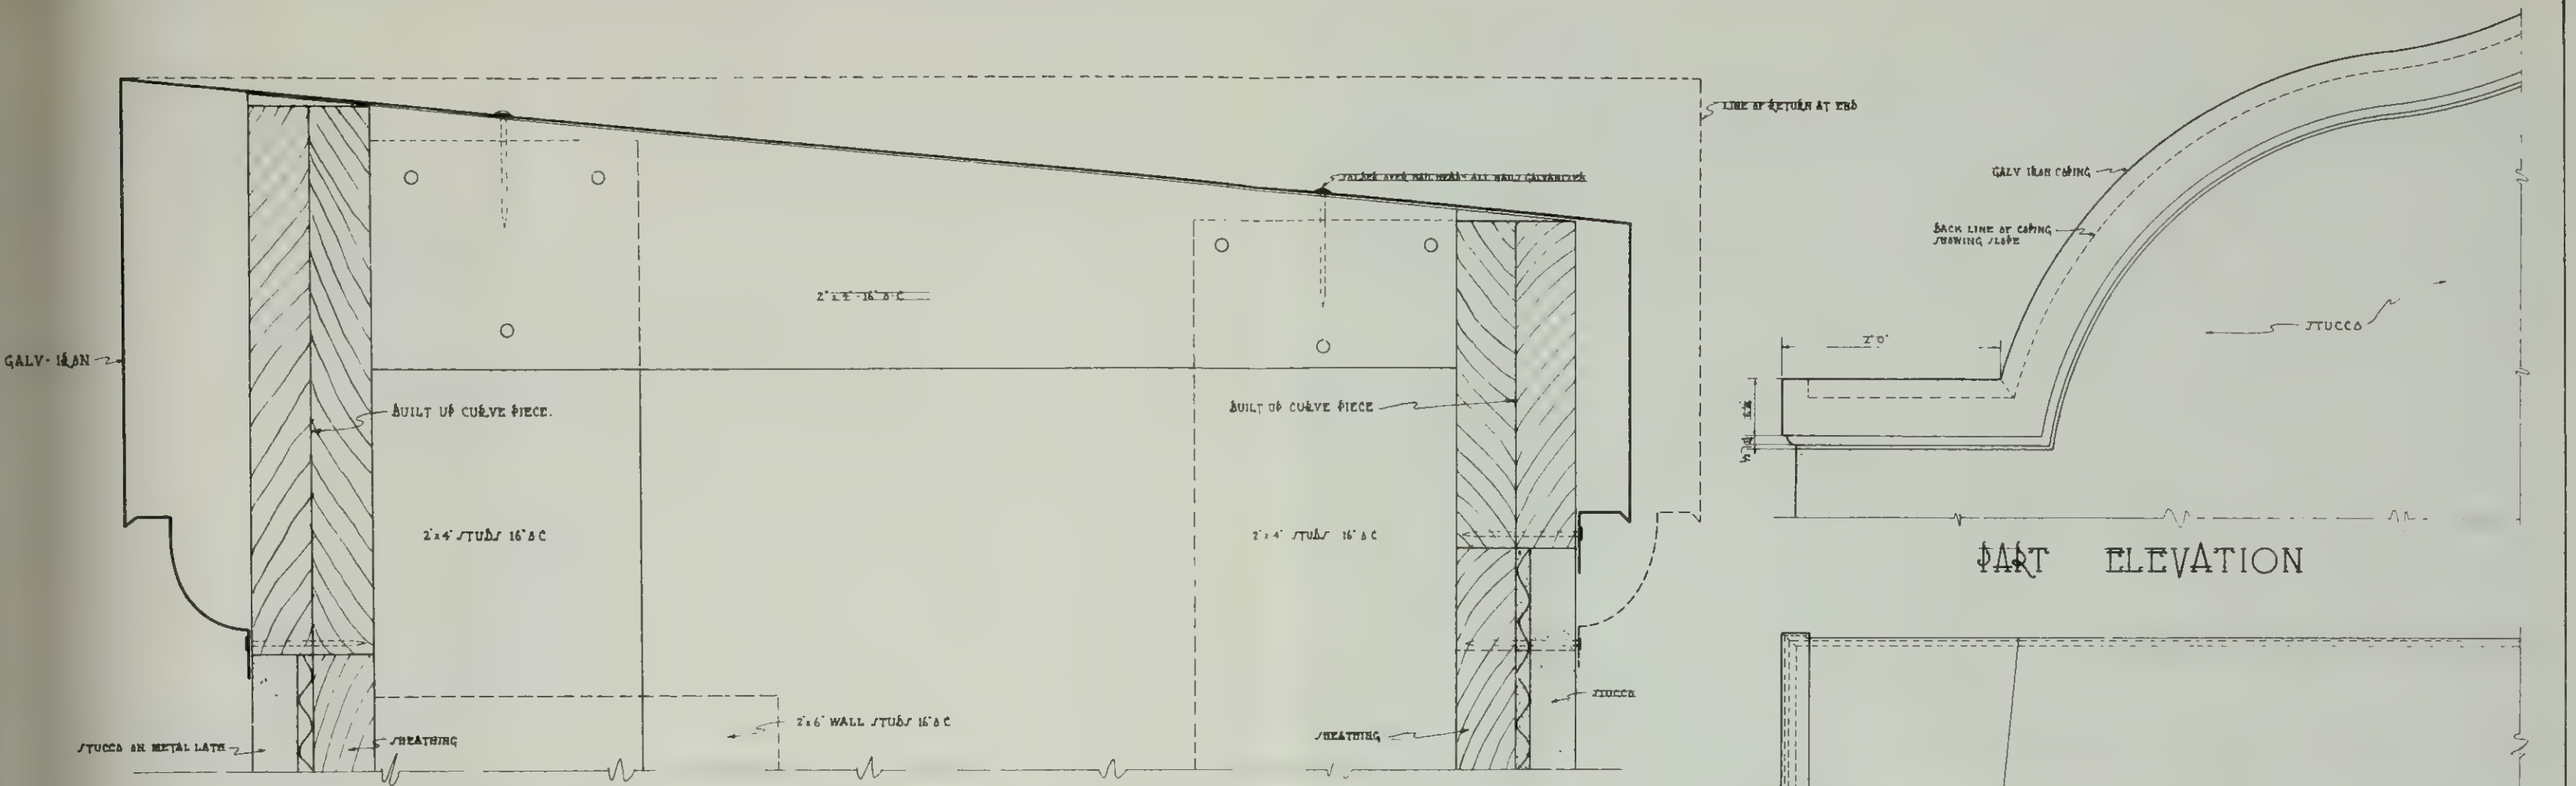
FULL SIZE SECTION OF COPING

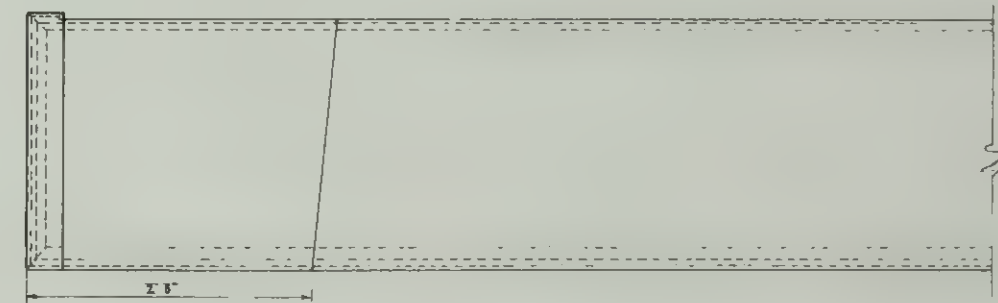
PART PLAN
SCALE 1/2" = 1' 0"

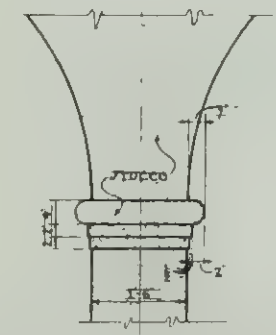
DETAIL OF COLUMN CAP
SCALE 1/2" = 1' 0"

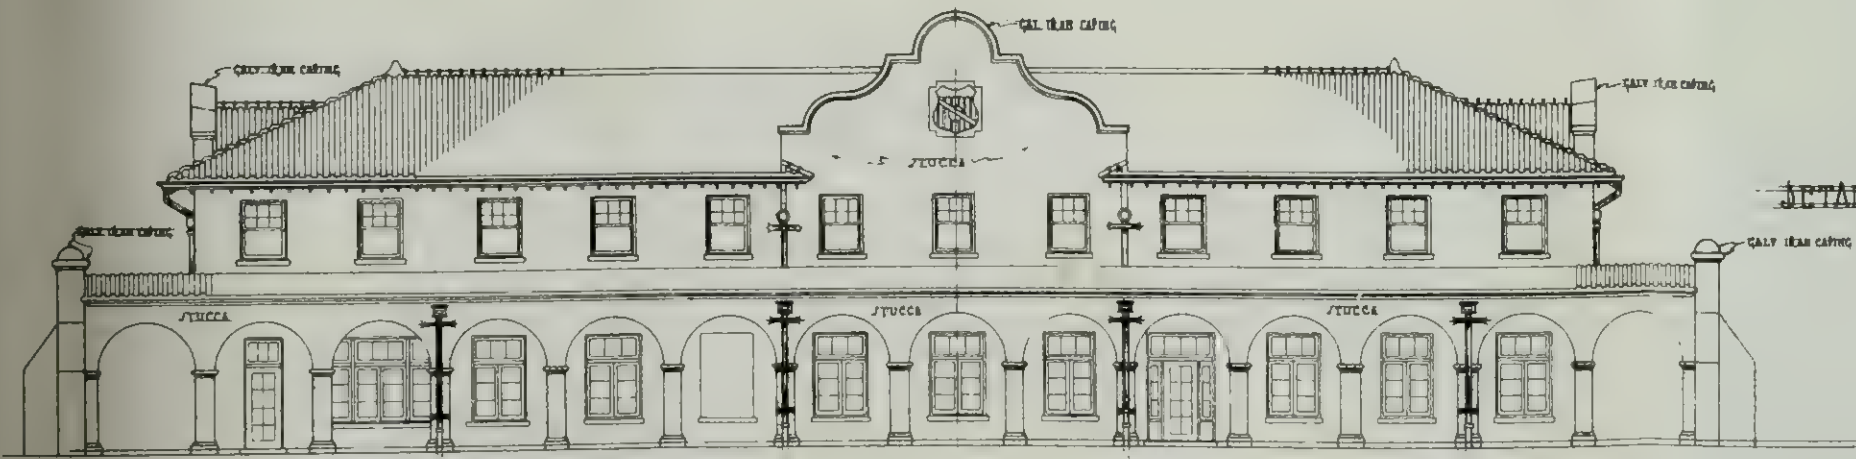
TRACK SIDE ELEVATION
SCALE ONE INCH EQUALS EIGHT FEET
OTHER ELEVATIONS TREATED SIMILAR

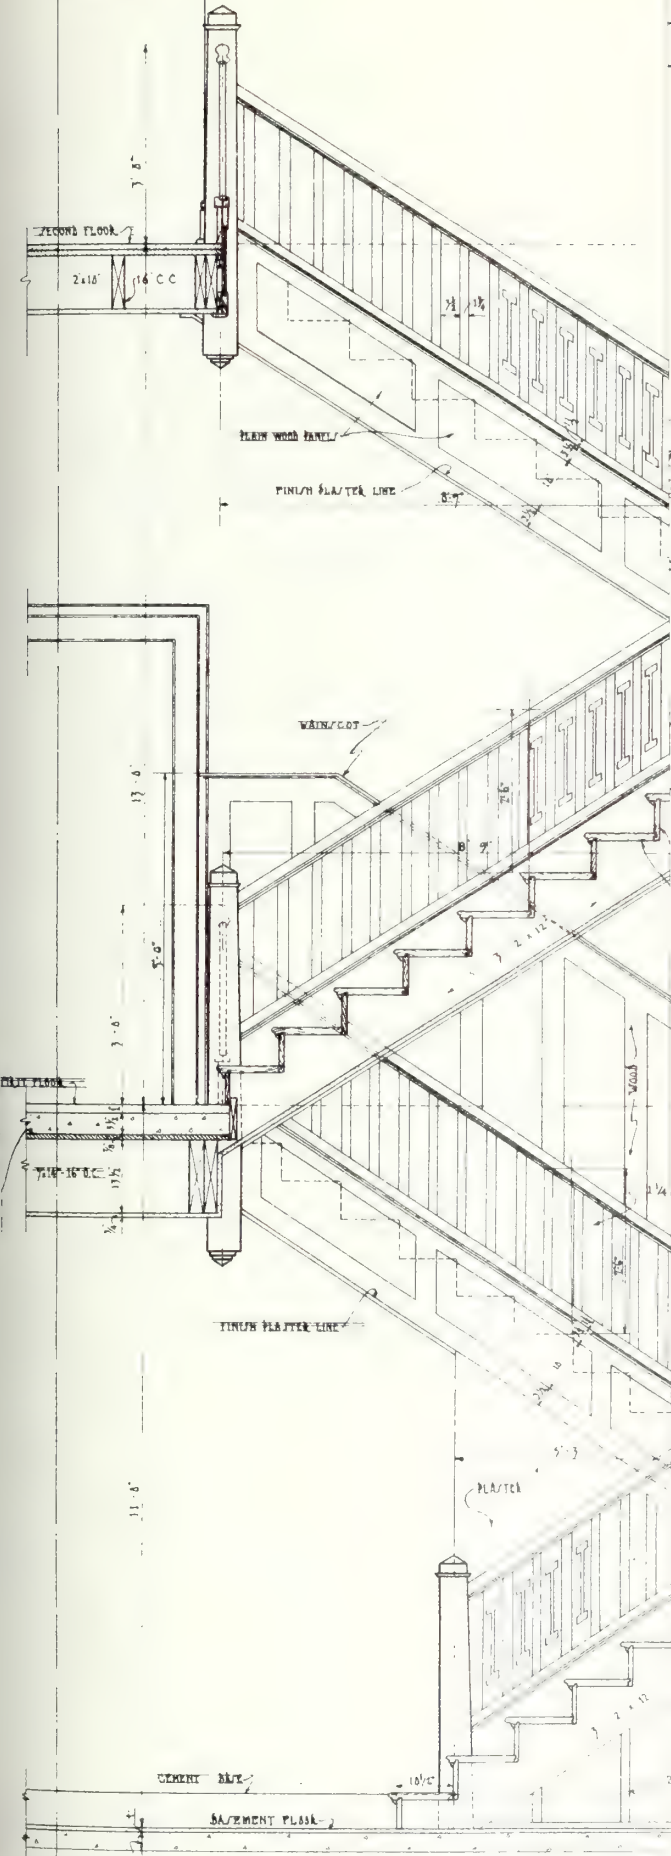
CHAIR RAIL
FOR READING RM. BILLIARD RM. TOILETS
AND CORRIDORS

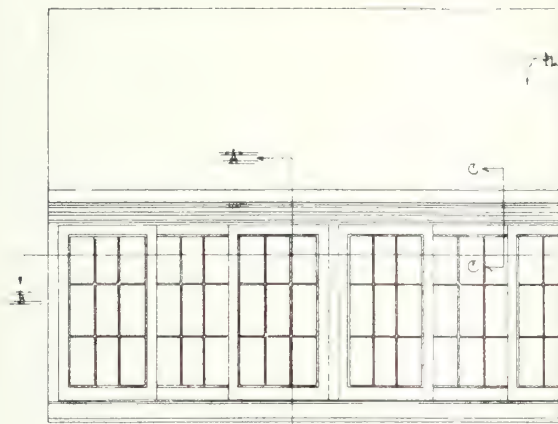
DETAIL OF BOOK CASE

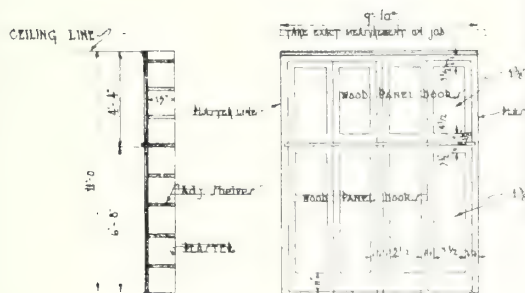
SECTION FRONT ELEVATION

LINEN CLOSET IN MACHINE ROOM

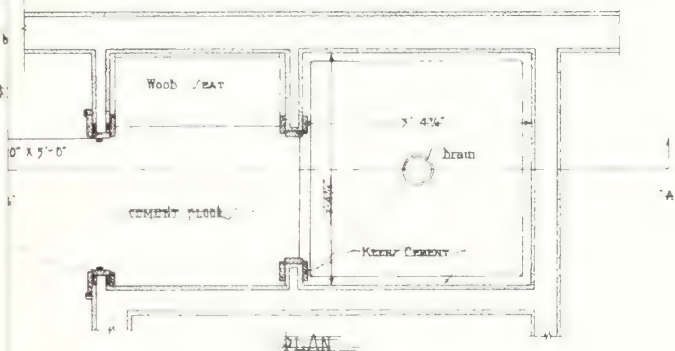
PLAN

SHOWER ON SECOND FLOOR

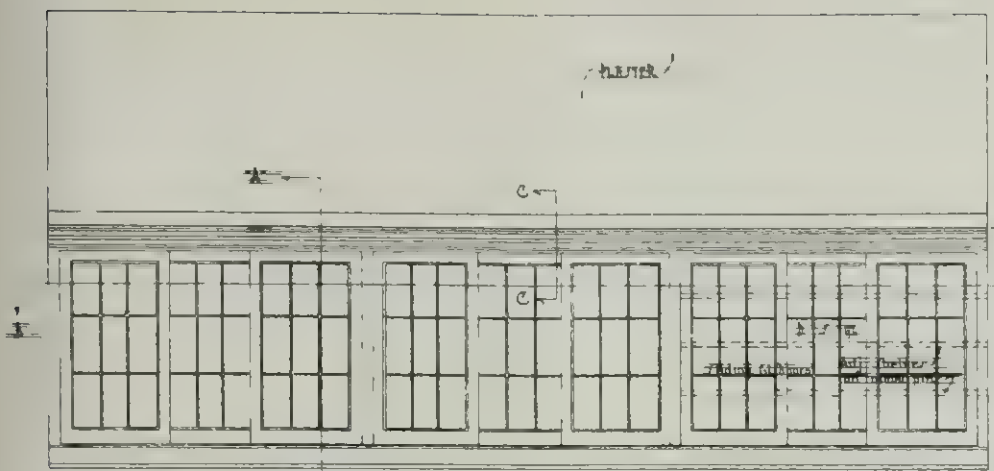
DETAIL OF BOOK CASE IN READING ROOM

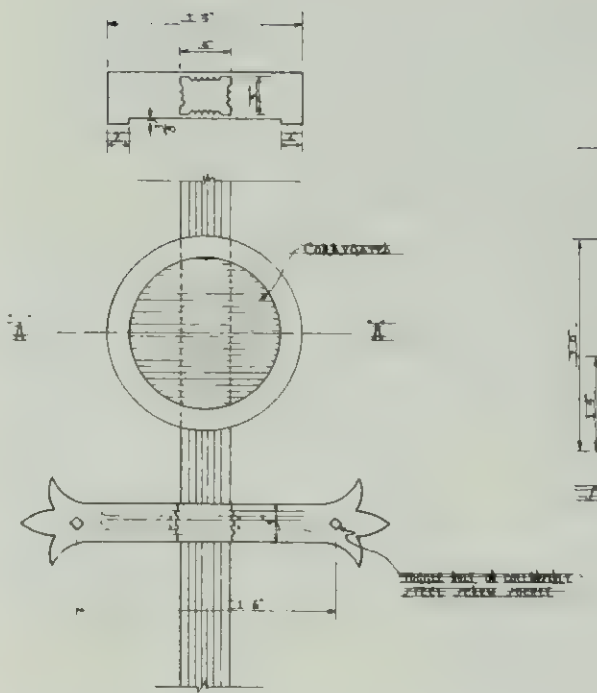
TYPICAL DETAIL OF DOWN SPOUT

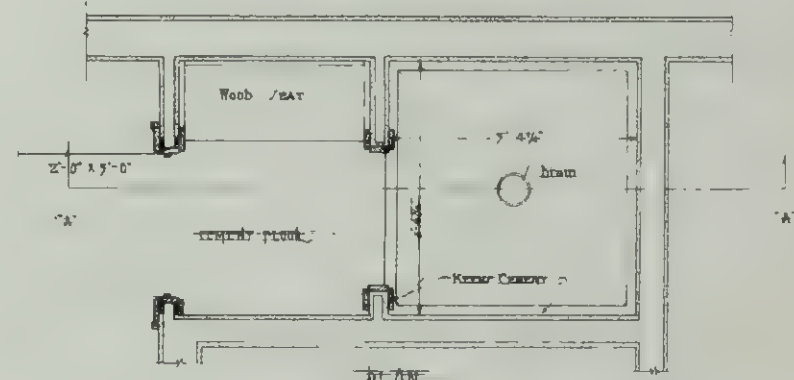
PLAN

DETAIL OF SHOWER ON SECOND FLOOR

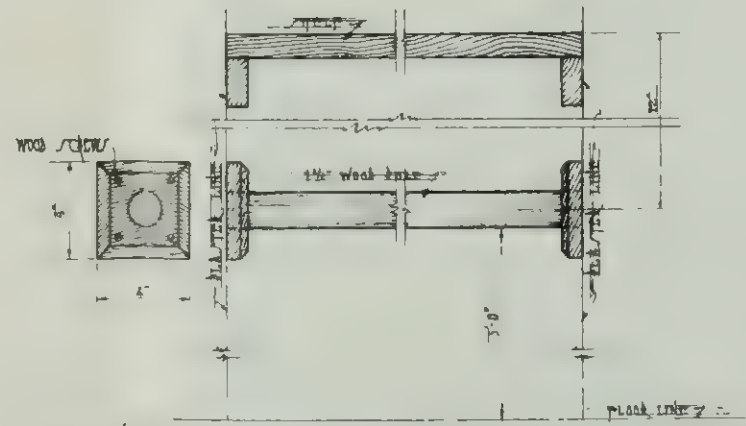
DETAIL OF HOLE FOR CLOTHES CLOSET
